AFFDL-TR-79-3118  
Volume III

DURABILITY METHODS DEVELOPMENT  
VOLUME III  
STRUCTURAL DURABILITY SURVEY:  
STATE-OF-THE-ART ASSESSMENT

B. J. PENDLEY  
S. P. HENSLEE  
S. D. MANNING  
GENERAL DYNAMICS CORPORATION  
STRUCTURAL AND DESIGN DEPARTMENT  
FORT WORTH DIVISION  
FORT WORTH, TEXAS

TECHNICAL REPORT AFFDL-TR-79-3118, VOL. III

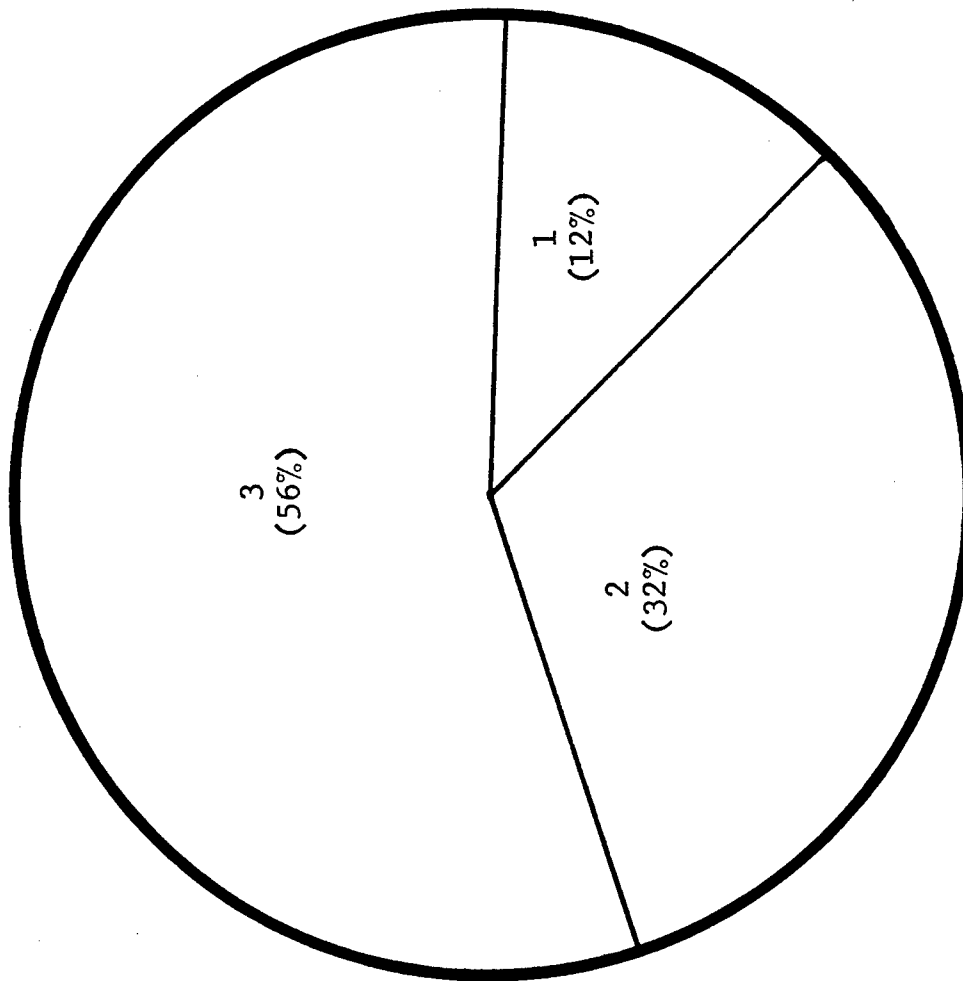
FIGURE 10 F-111A (FW#1) Wing Carry-Through Box Component  
Test Results

- 1 4 Cracking Incidents  
Emanating From 4 of 235  
TaperLok Holes
- 2 10 Cracking Incidents +  
Catastrophic Failure  
Emanating From 11 of 24  
3/16" Dia. Straight Holes
- 3 19 Cracking Incidents  
Emanating from 19 of 1450  
Close Tolerance Holes
- 4 0 Cracking Incidents  
Emanating From 5 Fuel Flow  
Cutouts and 1 Fuel Flow  
Drain Hole

34 TEST FAILURE INCIDENTS  
(Block 4 of Planned 40 Block Spectrum)

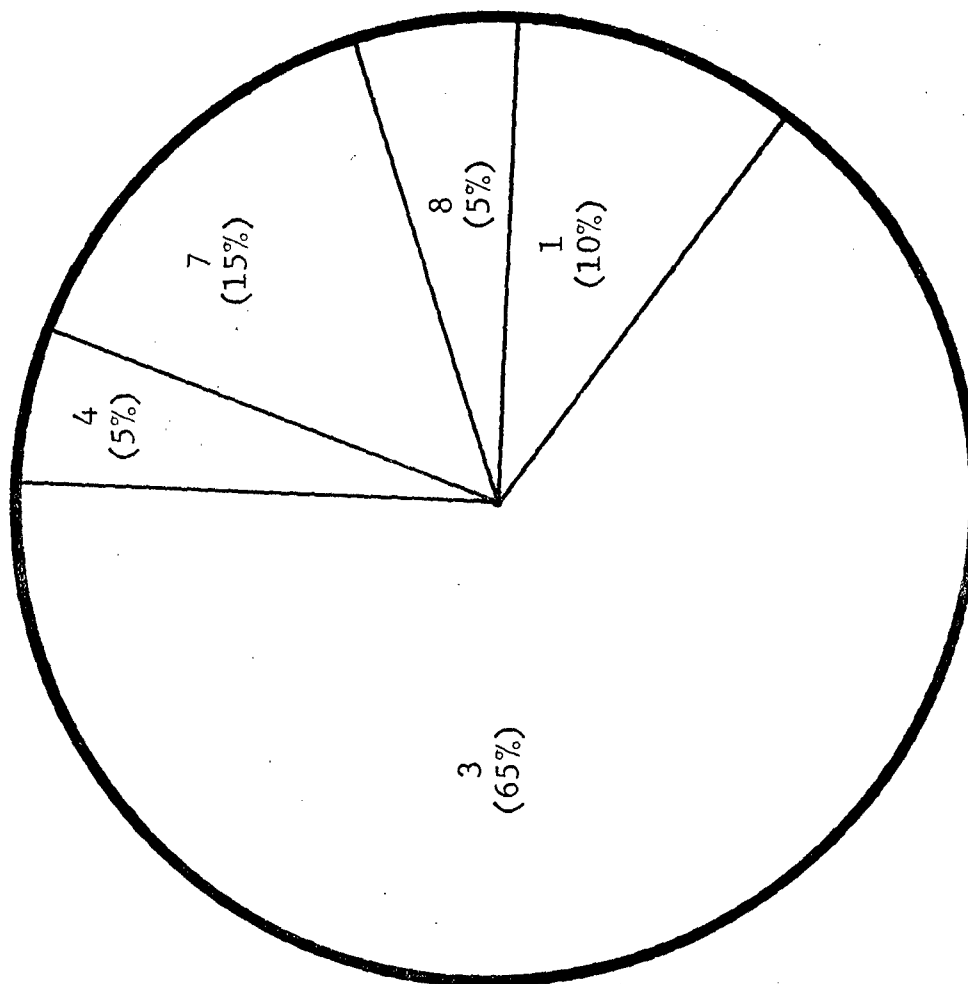
FIGURE 13 F-111A (A-4) L/H Wing Test Program Results

20 TEST INCIDENTS  
(40000 (+) Equivalent Flight Hours)

- 1 2 Incidents of Broken Fasteners
- 2 0 Receptacle Failure
- 3 13 Incidents of Cracking Including 1 Catastrophic
- 4 1 Incident of Panel Delamination
- 5 0 Shim Failure
- 6 0 Gouge, Dents, Scratch
- 7 3 Incidents of Galling, Wear, Non-Hole Roundness
- 8 1 Other

NOTE: R/H Wing Failed Catastrophically From 1 Fuel Drain Hole @ 30.5 Blocks of Planned 40 Block Spectra.

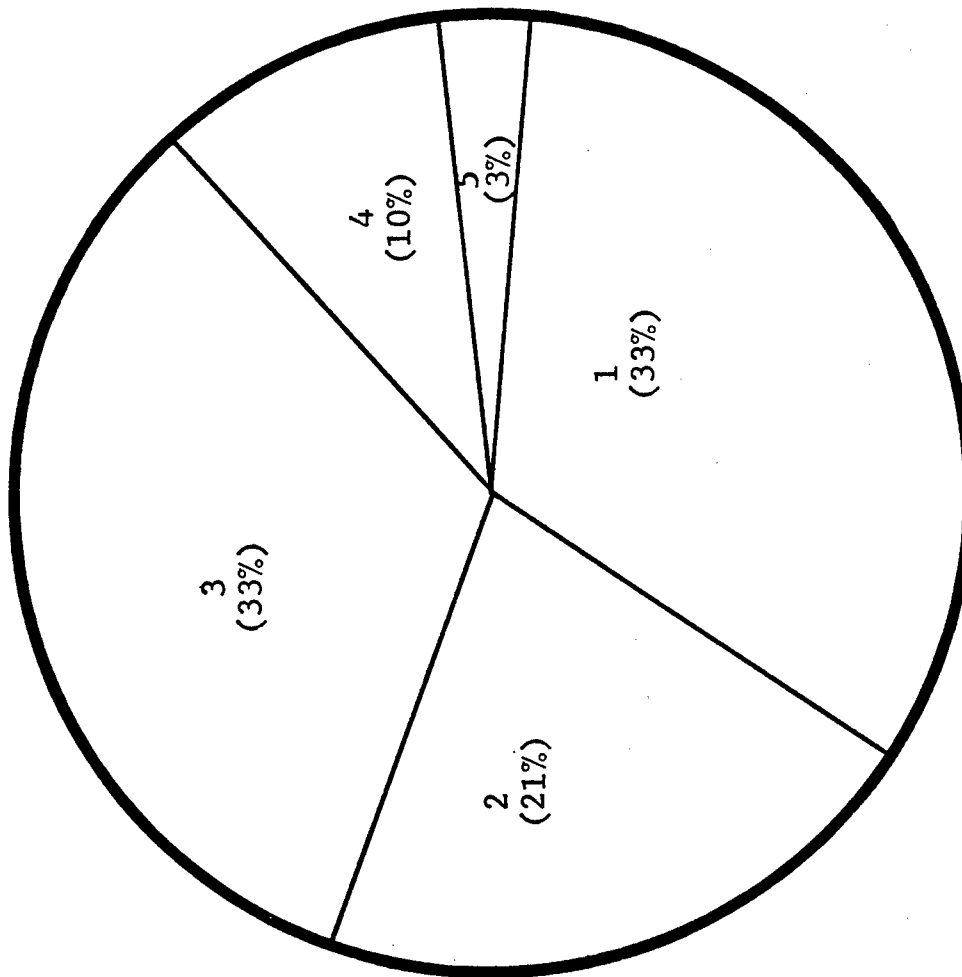
FIGURE 16 F-16 Durability Airframe Test Results  
For 1st 8000 Hour Life

61 TEST FAILURE INCIDENTS  
(1st 8000 HOUR SERVICE LIFE)

NOTE: All Parts Experiencing Cracking Were Redesigned For Production Configuration

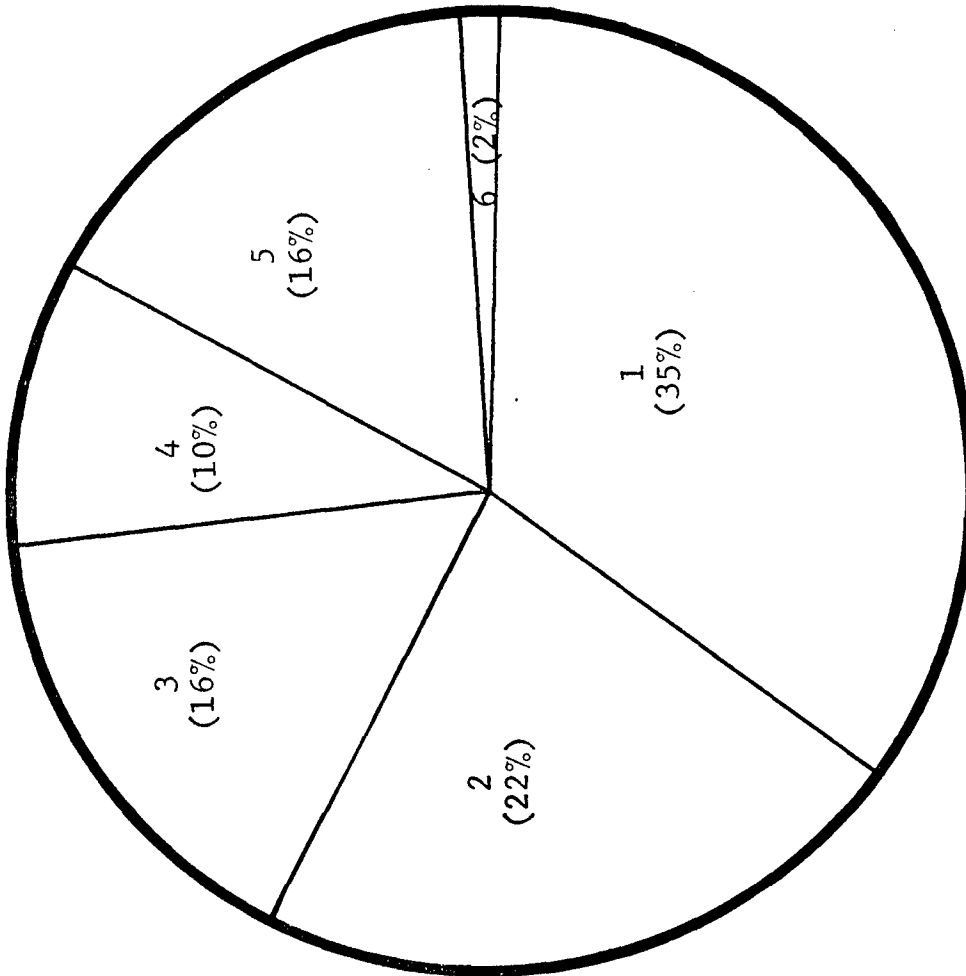
FIGURE 19 F-16 Durability Airframe Test Results  
For 2nd 8000 Hour Life

63 TEST FAILURE INCIDENTS  
(2ND 8000 HOUR SERVICE LIFE)

NOTE: All Parts Experiencing  
Cracking Were Redesigned  
for Production Con-  
figuration.

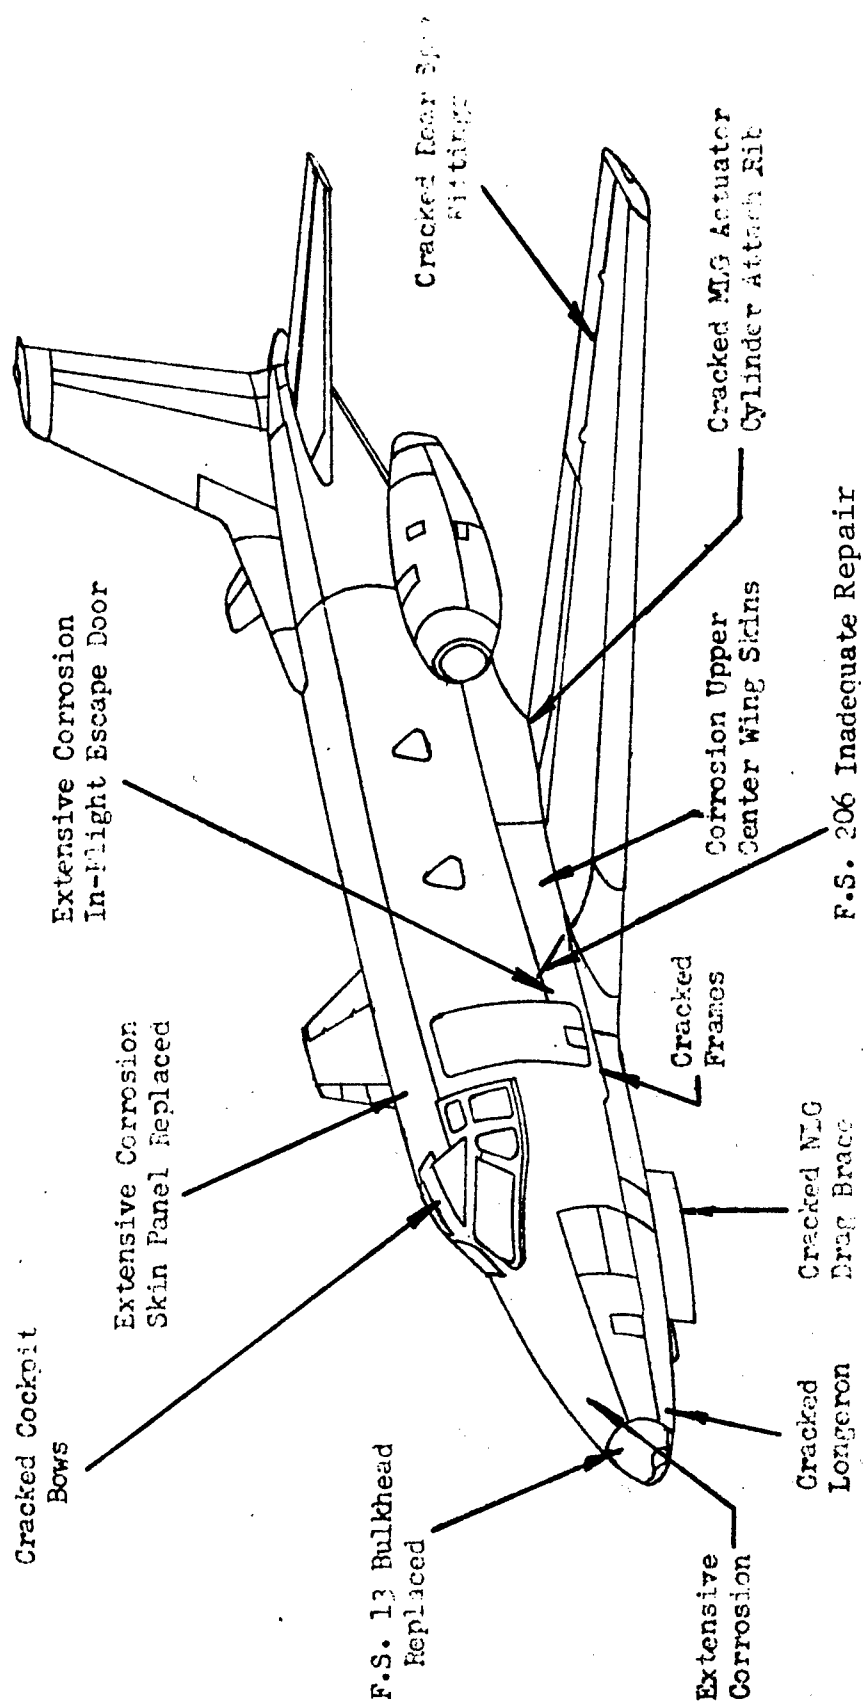
FIGURE 22 ACI FAILURE AREAS T-39A S/N 60-3490 PACAF/TAN SON NHUT

Figures 22 and 23 show the problem areas for two different aircraft.

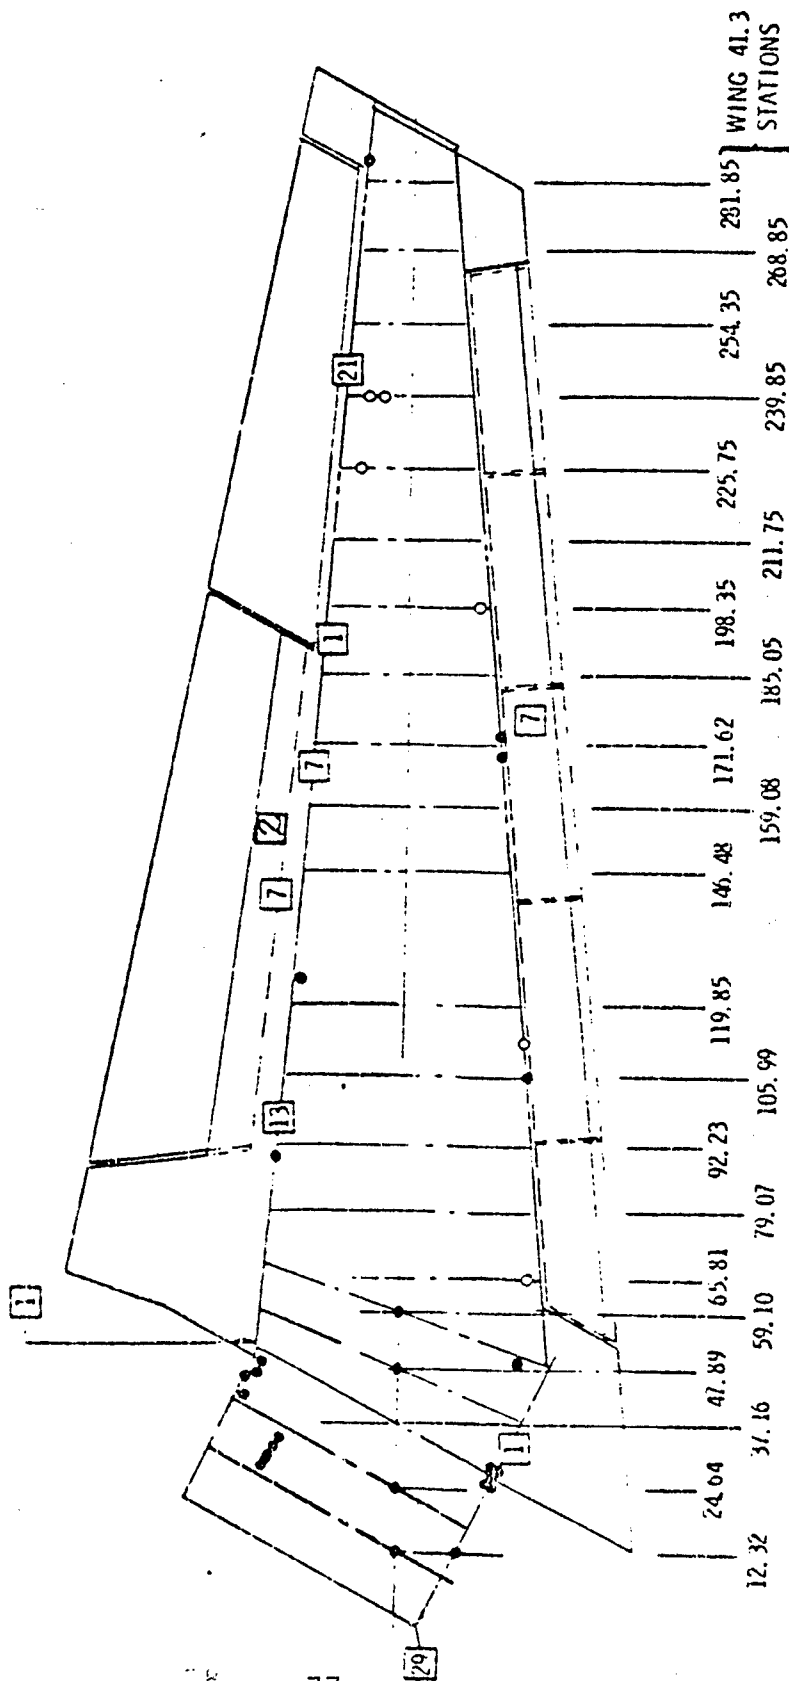
FIGURE 27 T-39A Left Wing Crack Distribution - Service & Test

- [xx] 89 FIFT CRACKS IDENTIFIED DURING REMAN PROGRAM ON 130 T 39A AIRCRAFT.
  - IWR SURF } CRACKS IDENTIFIED AT TEST TERMINATION
  - UPPER SURF } & TEARDOWN X (S.L.E.P. TEST)
- TOTAL CRACKS = 26

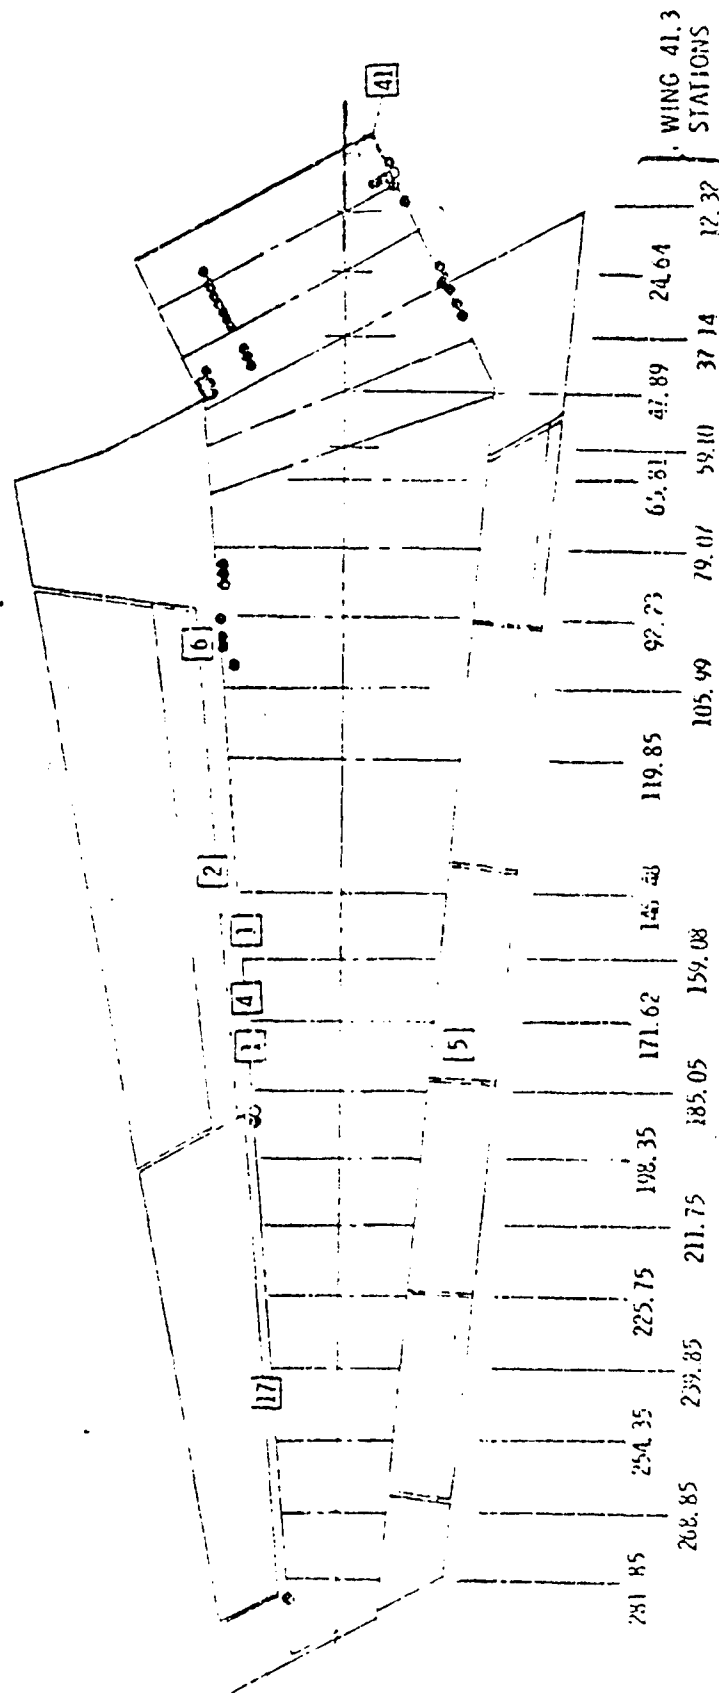
FIGURE 28 T-39A Right Wing Crack Distribution - Service & Test

- [x] 77 FLEET CRACKS IDENTIFIED DURING REMAN PROGRAM OF 130 T-39A AIRCRAFT.
- IWR SURF. } CRACKS IDENTIFIED AT TEST TERMINATION (S.L.E.P. TEST)
- UPPER SURF. } & TEARDOWN TOTAL CRACKS = 42

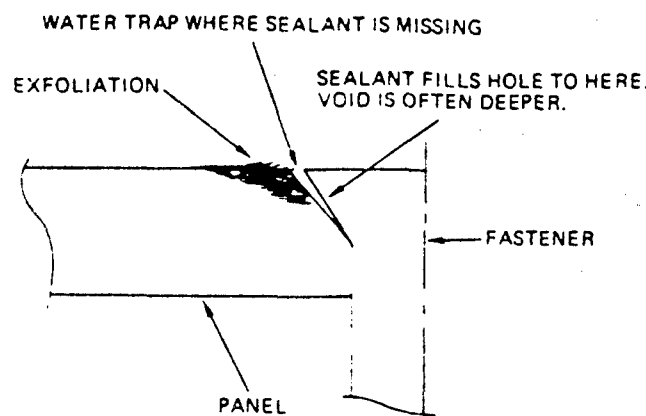
FIGURE 34 Corrosion Development Around Fasteners

The integrally stiffened wing panels of the C-141A aircraft were manufactured from 7075-T6511 extrusion. Steel Taper-Lok fasteners are used to attach the panels to one another and to various internal structure. The original finish system consisted of a MIL-C-8514 wash primer, followed by one coat of MIL-P-7962 primer and two coats of MIL-L-19537 acrylic lacquer. In time, this system cracked around the heads of the countersunk steel Taper-Lok fasteners permitting water entrapment and subsequent corrosion as depicted in Figure 34.

Solution to this problem was the application of two coats of MIL-S-81733, Type III polysulfide primer followed by two coats of MIL-C-83286 polyurethane.
